Shaked and Baked **BUT STILL STANDING**

by Don Pilz, CEMCO

Walls & Ceilings Magazine, October 2017, reprinted with edits approved by Don Pilz.

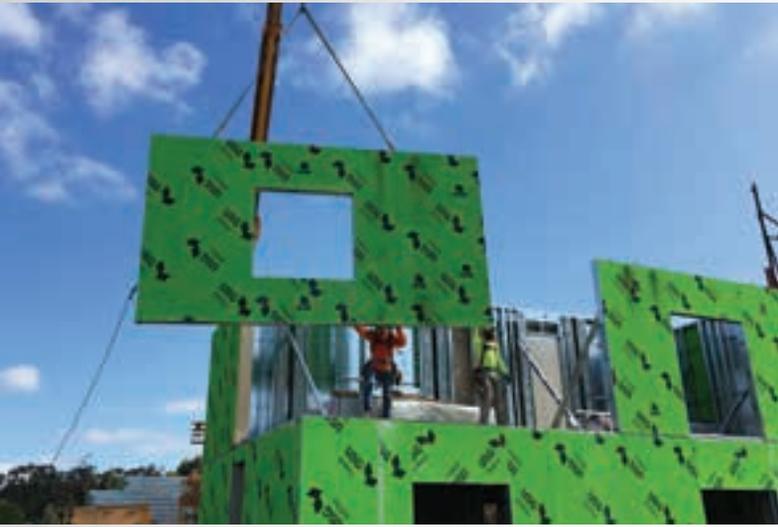
Photo 1: A six-story building was panelized and erected on a shake table at UCSD.

Last summer, a six-story steel framed structure withstood multiple, massive earthquakes and fires in San Diego. If you didn't hear about such an event, here's the story. Researchers at UCSD Jacobs School of Engineering put a 6-story, lightweight, cold-formed steel building through a series of scaled motion earthquakes.

This was the tallest cold-formed structure (CFS) steel building to ever undergo tests on a shake table. This type of building is lighter than a concrete building of the same height, so it has less mass to generate damaging forces.

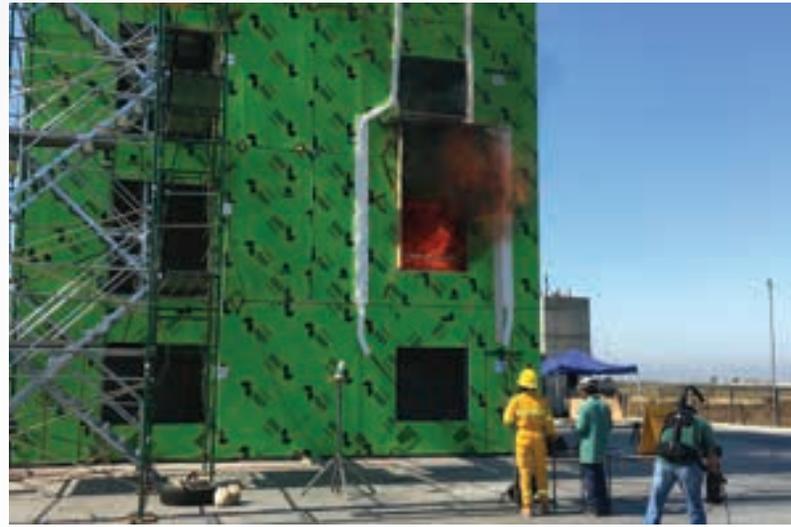
Photo 2: After a series of simulated earthquakes, the second and sixth floor were set on fire to analyze the full effects of a natural disaster.

The test building was subjected to a sequence of seven earthquake motions prior to fire tests on the second and sixth floors, with two more earthquake motions following. The input earthquake motions adopted for the shake table testing were selected from four historical earthquake records, namely: Rio Dell Overpass from the 1992 Cape Mendocino earthquake in California; both Canoga Park and Rinaldi Receiving Station from the 1994 Northridge earthquake in California; and Curico from the 2010 Maule earthquake in Chile.

Fire Tests: Post-flashover conditions were achieved in all six compartment fire tests at the given ventilation conditions, with the corresponding maximum compartment temperatures ranging between 800°C and 1100°C (four out of six tests exceeding 1000°C).

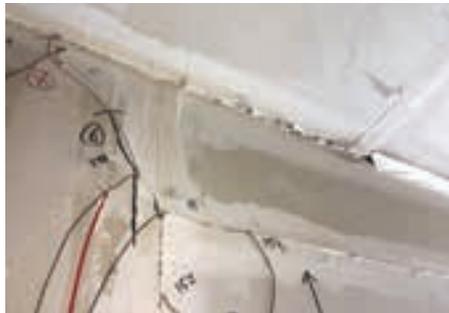
Photo 3: The results of the traditional method at the non-fire side where the paper tape cracks and pulls apart, which, in return, allows smoke to pass through the head-of-wall joint.

Knowing that the structure would be tested under substantial movement before and after a fire, it was important to see how the fire-rated building joints would perform. For the head-of-wall joints, two different forms of fire protection were installed and observed. The traditional method of paper tape and joint compound was applied to some of the perimeter joints while other head-of-wall joints were treated with CEMCO HOT ROD Compressible Intumescent Firestopping. Photo 3 shows the results of the traditional method at the non-fire side where the paper tape cracks and pulls apart, which, in return, allows smoke to pass through the head of the wall joint. Photo 4 shows the HOT ROD Compressible Firestopping on the non-fire side. Although the double metal door failed and allowed fire and smoke to pass through the door, fire or smoke was unable to pass through the head of the wall joint as indicated in the clean, off-white seal line between the ceiling and the wall. Photo 5 shows HOT ROD on the fire side. As shown in the photo, the intumescent material expands under fire and seals against the ceiling, which prevents any smoke from passing to the non-fire side.

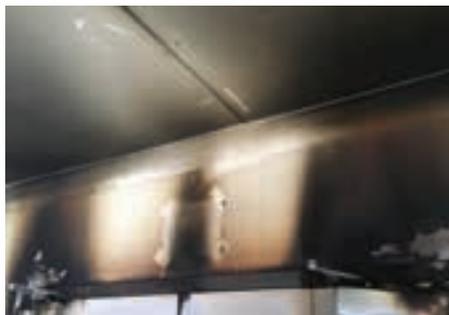
Photo 4: The HOT ROD Compressible Firestopping on the non-fire side. Although the double metal door failed and allowed fire and smoke to pass through the door, fire or smoke was unable to pass through the head-of-wall joint as indicated in the clean, off-white seal between the ceiling and the wall.

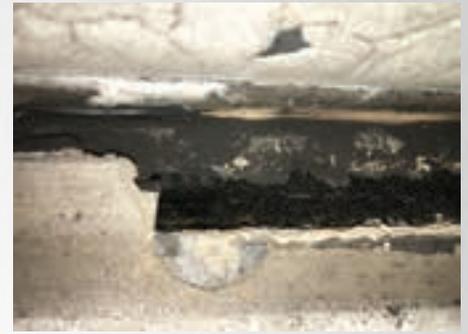
Photo 5: HOT ROD on the fire side. The intumescent material expands under fire and seals against the ceiling which prevents any smoke from passing to the non-fire side.
