Shaked and Baked BUT STILL STANDING

by Don Pilz, CEMCO

Last summer, a six-story steel framed structure withstood multiple, massive earthquakes and fires in San Diego. If you didn't hear about such an event, here's the story. Researchers at UCSD Jacobs School of Engineering put a 6-story, lightweight, cold-formed steel building through a series of scaled motion earthquakes.

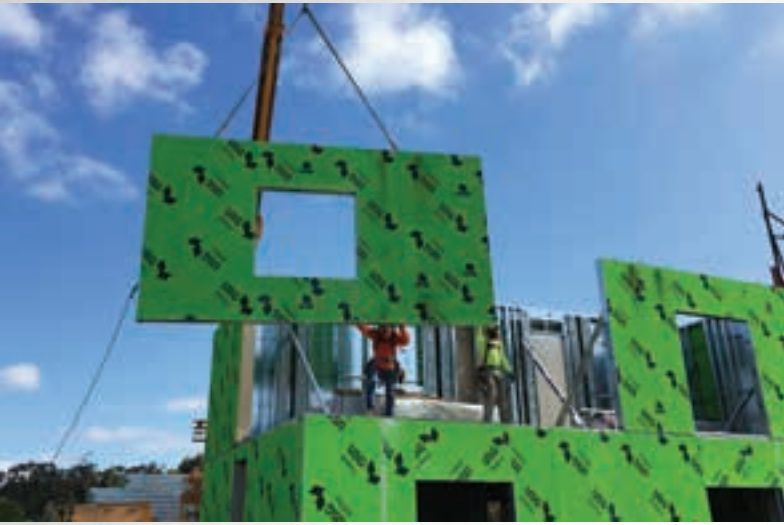
Photo 1: A six-story building was panelized and erected on a shake table at UCSD.

This was the tallest cold-formed structure (CFS) steel building to ever undergo tests on a shake table. This type of building is lighter than a concrete building of the same height, so it has less mass to generate damaging forces.

The purpose of the UCSD shaker table test was to construct a building per the current CBC & ASCE 7-10 design requirements at an $R = 6.5$. Using a combination of cold form steel framing, Sure-Board® wall and diaphragm shear (series 200 & 200S), as well as Zone 4 tie down system, the building was then subjected to a real-world earthquake scenario. This building was not built on "performance-based design" as most of the predecessors before, thus giving a *true outcome* of how a field built structure might react in a real earthquake. Some of the benefits that this system can offer in this type of construction are its inherent non-combustibility, higher shear and diaphragm capabilities compared to

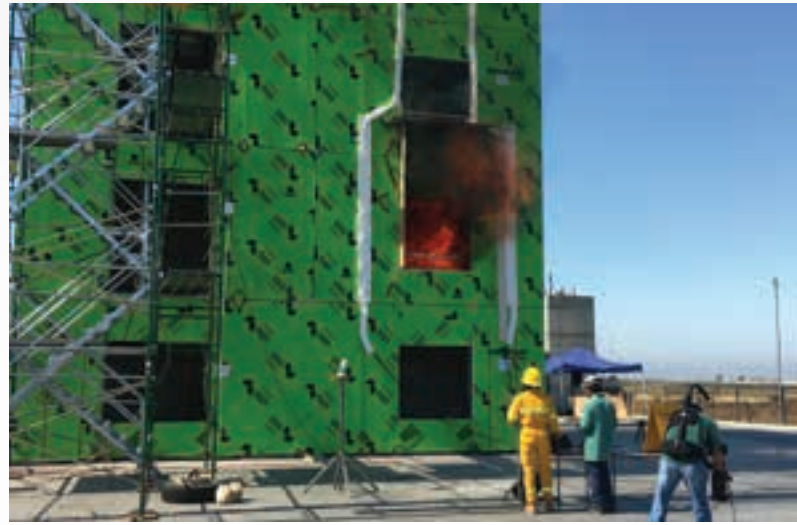
Photo 2: After a series of simulated earthquakes, the second and sixth floor were set on fire to analyze the full effects of a natural disaster.

The test building was subjected to a sequence of seven earthquake motions prior to fire tests on the second and sixth floors, with two more earthquake motions following. The input earthquake motions adopted for the shake table testing were selected from four historical earthquake records, namely: Rio Dell Overpass from the 1992 Cape Mendocino earthquake in California; both Canoga Park and Rinaldi Receiving Station from the 1994 Northridge earthquake in California; and Curico from the 2010 Maule earthquake in Chile.

Fire Tests: Post-flashover conditions were achieved in all six compartment fire tests at the given ventilation conditions, with the corresponding maximum compartment temperatures ranging between 800°C and 1100°C (four out of six tests exceeding 1000°C).

The elevated temperature caused significant degradation of interior fire rated gypsum wallboards on sheet steel and plain fire rated gypsum wallboards leading to the loss of some structural strength.

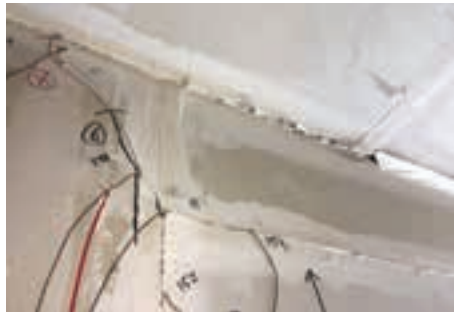
Photo 3: The results of the traditional method at the non-fire side where the paper tape cracks and pulls apart, which, in return, allows smoke to pass through the head-of-wall joint.

Knowing that the structure would be tested under substantial movement before and after a fire, it was important to see how the fire-rated building joints would perform. For the head-of-wall joints, two different forms of fire protection were installed and observed. The traditional method of paper tape and joint compound was applied to some of the perimeter joints while other head-of-wall joints were treated with CEMCO HOT ROD Compressible Intumescent Firestopping. Photo 3 shows the results of the traditional method at the non-fire side where the paper tape cracks and pulls apart, which, in return, allows smoke to pass through the head of the wall joint. Photo 4 shows the HOT ROD Compressible Firestopping on the non-fire side. Although the double metal door failed and allowed fire and smoke to pass through the door, fire or smoke was unable to pass through the head of the wall joint as indicated in the clean, off-white seal line between the ceiling and the wall. Photo 5 shows HOT ROD on the fire side. As shown in the photo, the intumescent material expands under fire and seals against the ceiling, which prevents any smoke from passing to the non-fire side.

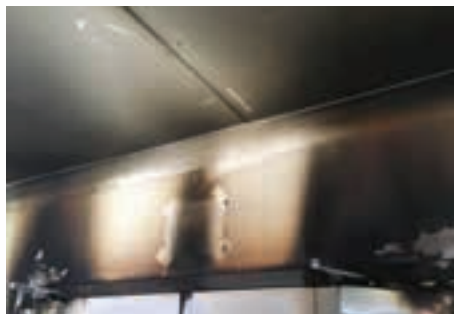
Photo 4: The HOT ROD Compressible Firestopping on the non-fire side. Although the double metal door failed and allowed fire and smoke to pass through the door, fire or smoke was unable to pass through the head-of-wall joint as indicated in the clean, off-white seal between the ceiling and the wall.

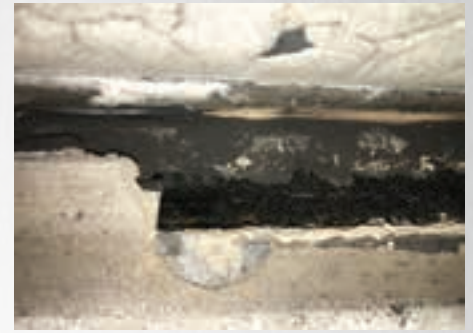
Photo 5: HOT ROD on the fire side. The intumescent material expands under fire and seals against the ceiling which prevents any smoke from passing to the non-fire side.
